June 9, 2021

Ref. Asbestos Survey Report
**Residence
821 Massachusetts Ave.
Arlington, MA**

Job: 821 Massachusetts Ave Arlington MA. – June 3, 2021

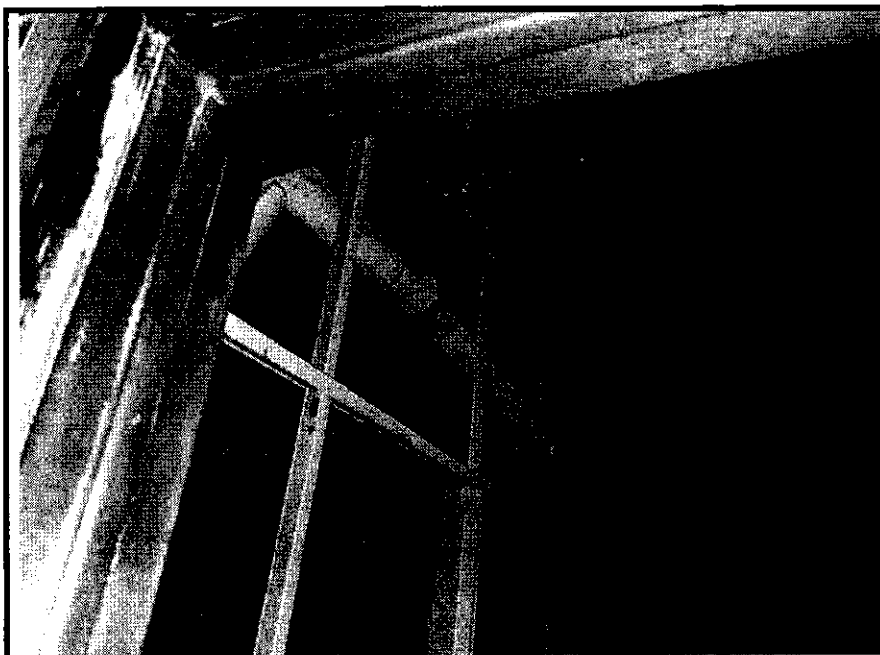
Above Ceiling Basement
Sample #5 A, B, C

Pipe Insulation Chrysotile= 50%

- The US EPA and MassDEP require all ACM be removed from a facility prior to the start of renovation or demolition activities if the materials may be disturbed by these activities. A licensed Asbestos Removal Contractor should remove identified ACM prior to the start of renovation or demolition activities in accordance with federal, state, and local regulations.

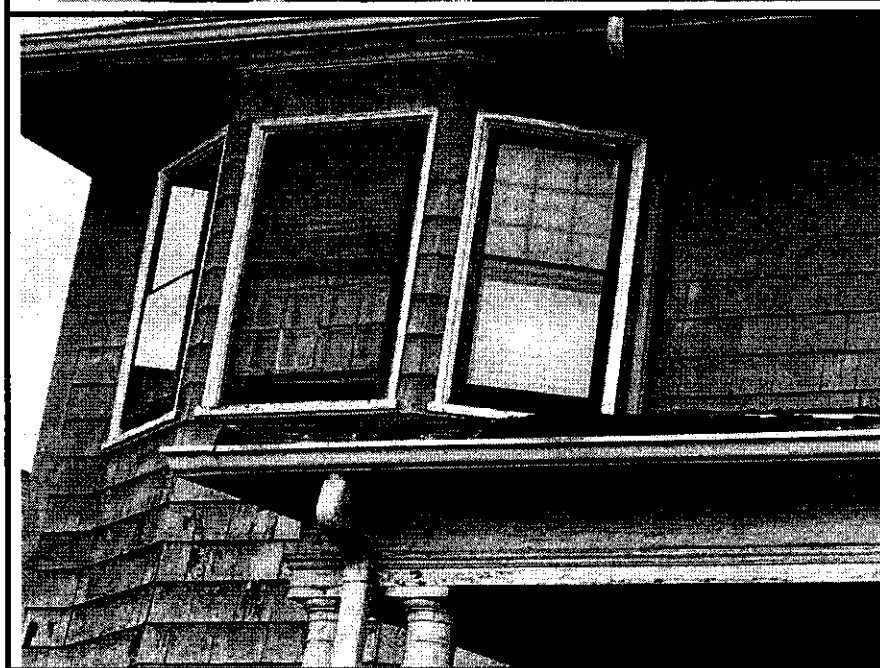
Exterior Windows
Sample #19 A, B, C

Glazing Chrysotile= 2%

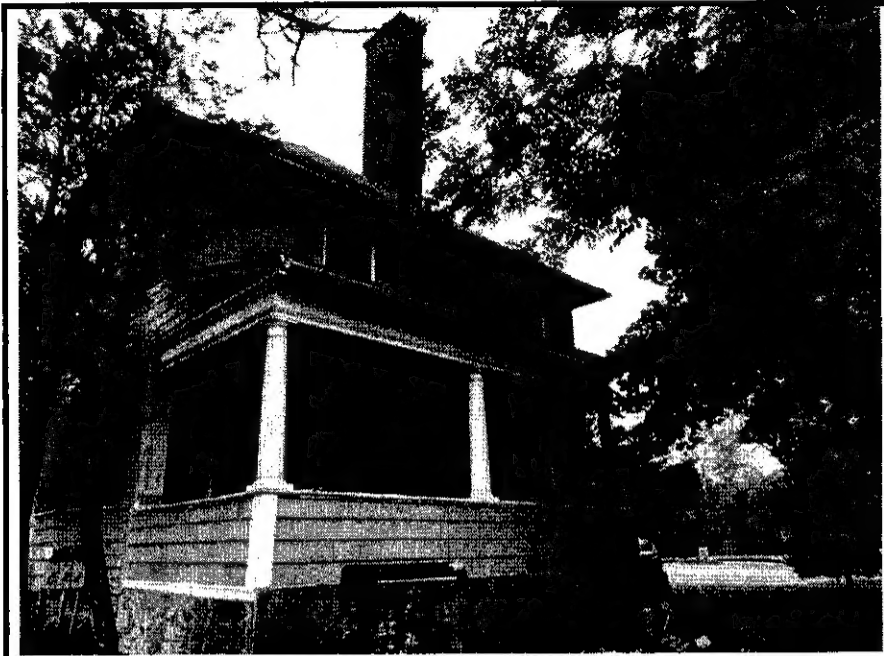
Flat Roof front and
right-side porch
Sample #20 A, B, C

Shingle Roof Chrysotile= 5%
 Tar Paper Chrysotile= <1 %

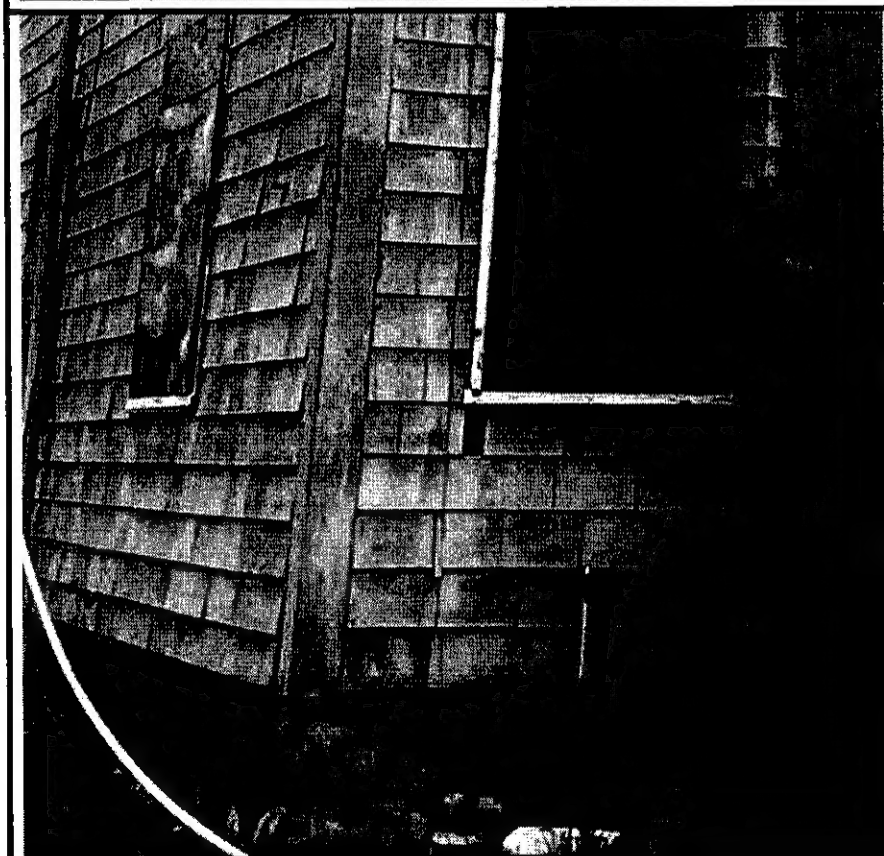
Behind Wood Siding
Exterior House
Samples #21 A, B, C

723135				Non-Fibrous 30	
21B	Tar Paper	Behind Wood Siding Exterior House	black	Cellulose 70	Detected Chrysotile < 1
723136				Non-Fibrous 30	
21C	Tar Paper	Behind Wood Siding Exterior House	black	Cellulose 70	Detected Chrysotile < 1
723137				Non-Fibrous 30
